# Sands of Time: a Renourished Beach vs. a Non-renourished Beach

Faculty Advisors: G. Maul and C. Combs, Department of Marine and Environmental Systems, Florida Institute of Technology

Engineering & Science  
Student Design Showcase  
at Florida Institute of Technology

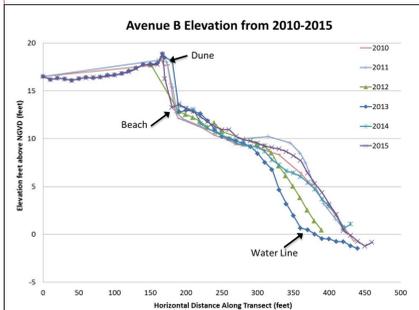
Figure 3: Comparison of elevation above National Geodetic Vertical Datum (NGVD) in feet versus horizontal distance in feet along Avenue B from 2010-2015.

Beach renourishment plays a vital role in coastal erosion. Avenue B, the renourished beach, had a greater sand loss than Ponce Landing, non-renourished beach, from Hurricane Sandy. After Hurricane Sandy a renourishment occurred between November 2013 and February 2014 which resulted in a net sand gain along the horizontal transect at Avenue B. This trend continued into the following year. The years prior to the renourishment were a loss in net sand. The significance tests show that the years surrounding the renourishment are different. In 2017, Brevard County plans on another renourishment that will cost 73 million dollars over the next five years (Waymer, 2015). Results from future studies should be interesting to show the elevation and the mean elevation difference between these years due to the renourishment and perhaps any other future significant meteorological occurrences that can affect these beaches.

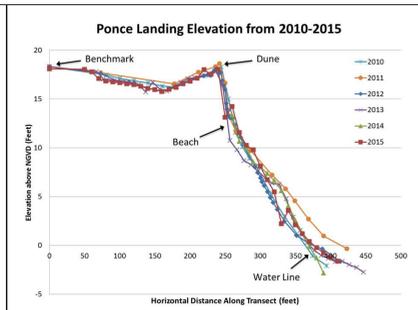
Figure 4: Comparison of elevation above National Geodetic Vertical Datum (NGVD) in feet versus horizontal distance in feet along Avenue B from 2010-2015.

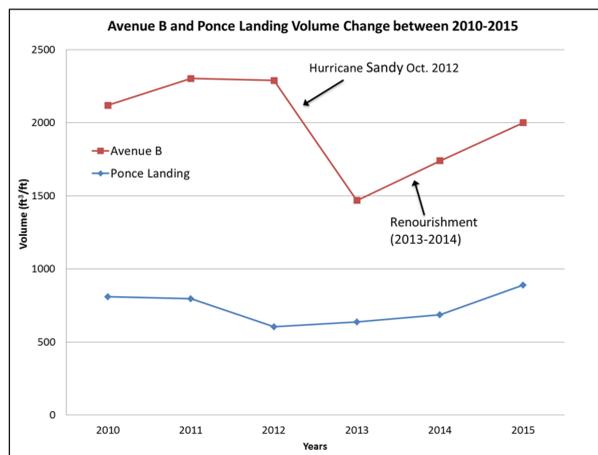
Figure 5: Comparison of the volumetric sand change at Ponce Landing and Avenue Beach from 2010-2015

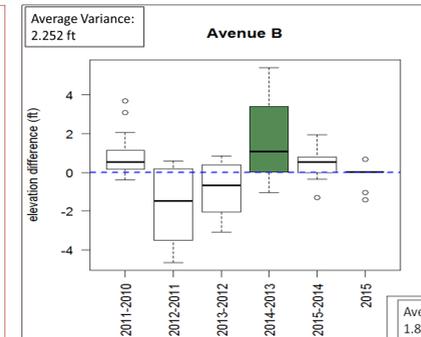
Figure 6: Box plots showing the distribution of the mean difference between 2010-2015 at Avenue B (green box plot is the renourishment year)

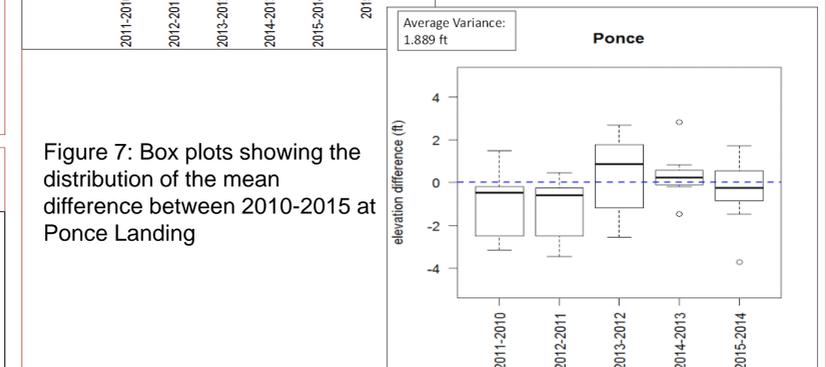
Figure 7: Box plots showing the distribution of the mean difference between 2010-2015 at Ponce Landing
