Influence of optical fiber coating damage in the light transmissivity characteristics of microbend sensors

Franz Campero^{1a}, Paul Cosentino^a, David Fleming^a, Edward Kalajian^a, and Barry Grossman^a
^aFlorida Institute of Technology, 150 W. University Blvd., Melbourne, FL, USA

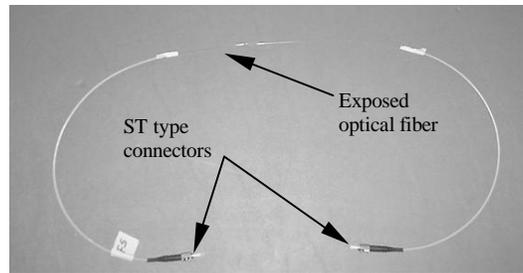
Figure 1. One-strand fiber optic sensor

To analyze the behavior of the optical fiber under contact with a deformer, a “one-strand” microbend sensor was built (Figure 1). The optical fiber lead ends on these one-strand sensors were fitted with Fiber Instrument Sales ST type connectors to allow light to be transmitted. Corning[®] 50/125/250 multimode optical fiber was used. In order to protect the fiber-connector joints a Kevlar[®] furcating tube was used. A length of approximately 35 centimeters of optical fiber was left exposed to allow direct contact with the deformer during testing.

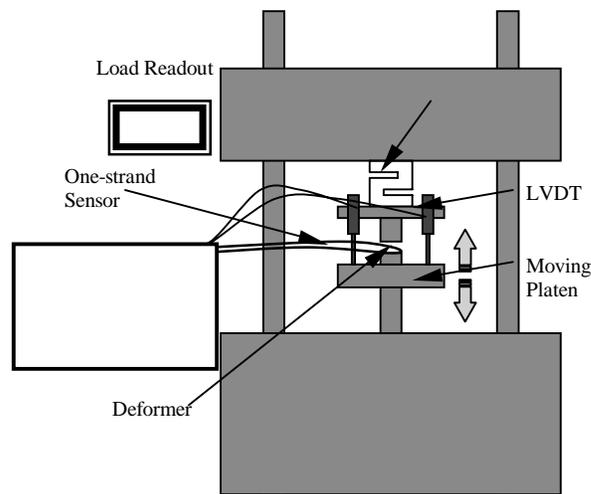
Figure 2. Schematic of fiber-deformer testing

The one-strand sensor testing methodology adopted simulated what occurs in a microbend sensor. Figure 2 shows a schematic of the mechanical testing conducted. One-strand optical fiber microbend sensor and deformer were placed on an unconfined compression apparatus (Figure 2) with their axes at an approximate angle of 90° and perpendicularly loaded by a monotonically increasing displacement; the speed of the moving platen was kept approximately constant during each test.

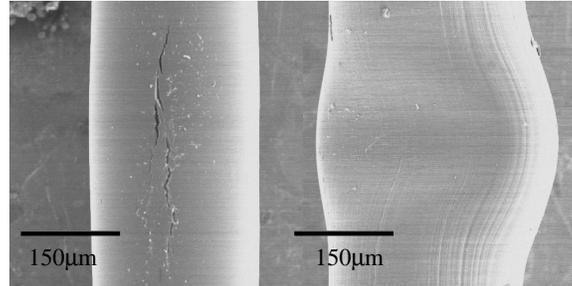
Figure 3. Optical fiber coating first crack manifestations (left). ETFE deformer (right): severe signs of plastic deformation.

To determine the load that caused coating fracture several sets of tests were conducted and halted at different load intervals. Scanning Electron Microscope (SEM) photographs were used to evaluate the first coating crack manifestation.

Because the sensitivity of the load cell and the load spacing in the tests it was estimated that coating fracture occurred at loads between 35 and 45 N. Cracks were observed to occur at the point of contact between deformer and optical fiber only. Noticeable glass-coating interface debonding was observed in specimens tested at loads greater than approximately 10 N. Because of the viscoelastic nature of the coatings, the debonding area increased with time.

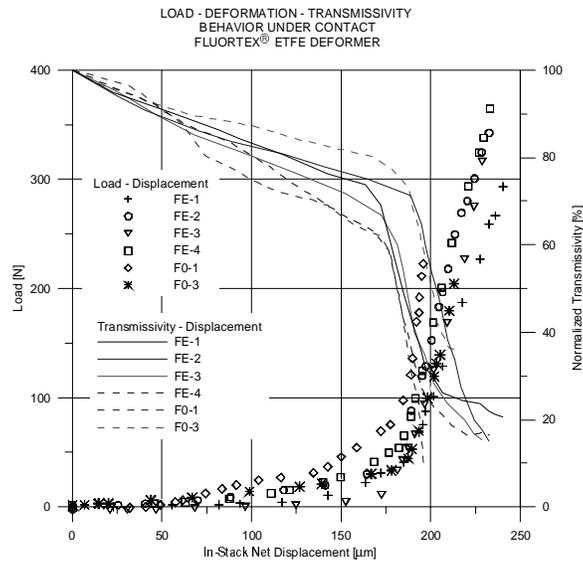
Figure 4. Load-displacement-transmissivity curves of six one-strand sensors tested with 250- μm diameter Fluortex[®] ETFE deformer under contact.

test speed was controlled by carefully monitoring the displacement rate of the moving platen. It was observed that the transmissivity decreased linearly up to about 60 to 70 % where a noticeable change in its curve slope occurred. After this abrupt change of slope, the transmissivity curves continued decreasing linearly with load increments until the test was stopped. Figure 4 presents the load-displacement-transmissivity curves and Table 3 summarizes the results.

The strain rate had little effect on the displacements at the light transmissivity drop (change of slope). In average, displacements recorded for sensors using Fluortex[®] ETFE deformers occurred at almost identical displacements to those predicted at coating fracture loads (between 35 and 45 N).

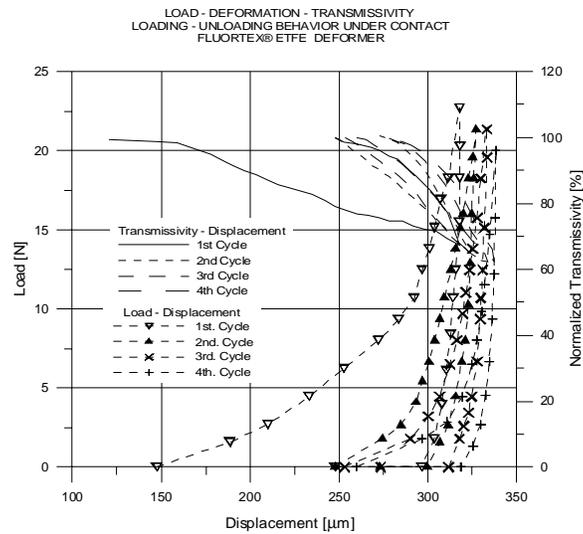
Figure 5. Typical loading-unloading curves for pre-coating fracture peak loads.

Because structures typically present different behaviors when comparing pre and post cracking conditions these tests were conducted at peak loads smaller and greater than the coating fracture loads determined by mechanical testing. Figure 5 presents four loading cycles to peak loads below coating fracture values.

After these four cycles, optical fiber and deformer were examined under the microscope. Glass-coating debonding was observed in the specimen. The deformer presented plastic deformations greater than those corresponding to the same load range observed previously. No cracks were observed on the optical fiber coatings.

A marked difference between the first and the following cycles was observed. The virgin sample load-displacement curves enclosed a larger area than the subsequent loops. The energy dissipated during each cycle was determined by numerical integration and is presented in Table 4. Subsequent cycles show a decrement in irreversible deformations. Table 5 presents displacements registered for each type of behavior, i.e., elastic, viscoelastic and irreversible for each cycle.

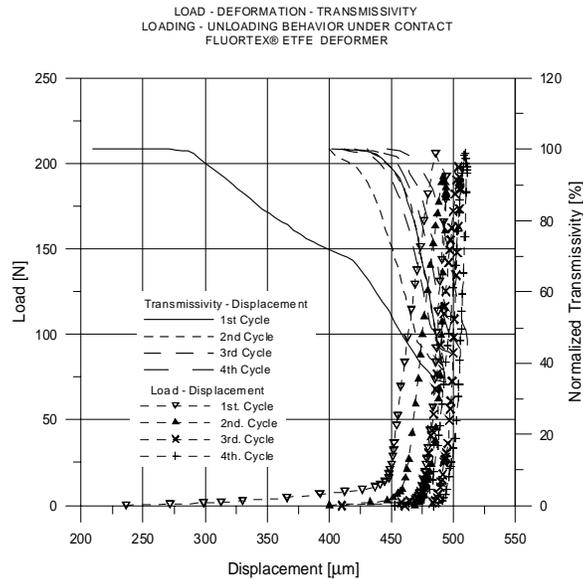
Figure 6. Typical loading-unloading curves for post-coating fracture peak loads.

Because of tolerance limitations in the measures of dissipated energy per cycle, cyclic testing was not conducted until constant dissipation energy values were attained. Figure 6 presents four loading-unloading cycles to peak loads greater than coating fracture loads.

The light transmissivity change of slope observed during the optical performance testing phase was present in the first loading-unloading cycle (Figure 6) but not in the subsequent cycles. This is because the coating fracture is a one-time event; therefore subsequent cycles do not present the previously observed slope change in the light transmissivity curves. Again, the energy dissipated during each cycle was determined by numerical integration and is presented in Table 6. Table 7 presents displacements registered for elastic, viscoelastic and irreversible behaviors for each cycle.

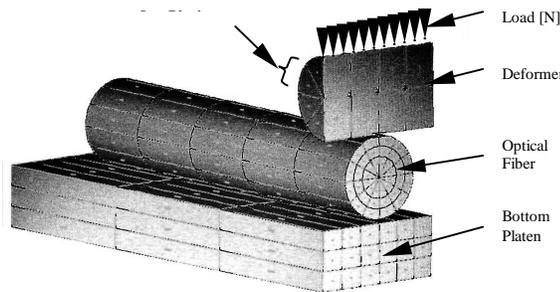
Figure 7. Three-dimensional Finite Element Mesh.

A Finite Element Analysis was performed to determine if the coating fracture loads measured during the experimental phase could be correlated to strength properties reported. *Mechanica*® (release 2001) was the code chosen for this analysis based on availability. Relatively simple three-dimensional Finite Element models were employed (Figure 7). Finite Element code limitations included modeling of elastic-viscoplastic behavior of polymers, crushing and crack propagation. Capabilities for simulating strain rate-dependent materials such as polymers and acrylate-like materials were also absent.

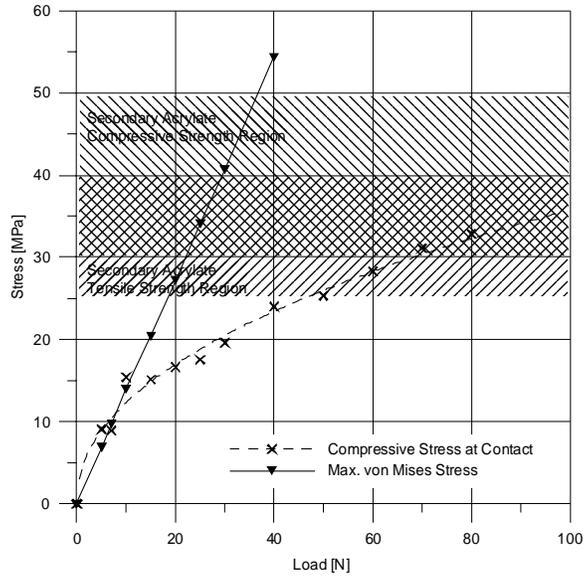
Figure 8. Finite Element load-stress results.

The Octahedral Shear Stress Yield was the adopted coating failure criterion. Result from the models showed that maximum stresses were developed at the inner surface of the secondary coating. Other important stresses were those developed at the contact region. Model results were plotted as load-stress and displacement-stress curves to assist in correlating model results to experimental results. Figures 8 and 9 show these curves.

Loads and displacements predicted by the Finite Element models were similar to those observed experimentally when using the maximum reported coating tensile strength (40 MPa). Table 8 summarizes experimental and numerical models results.

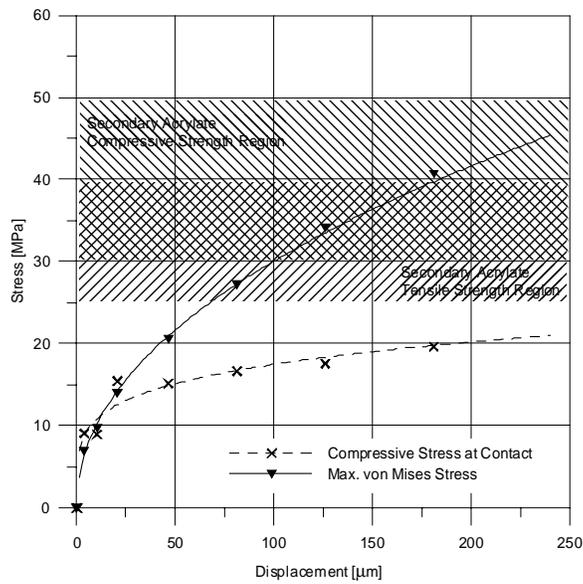
Figure 9. Finite Element displacement-stress results.
